Attachment B – TV Reports

2026 Sewer Main to Service Lateral Connection Testing
and Sealing Project

Sewer CCTV Assessment Detail Report

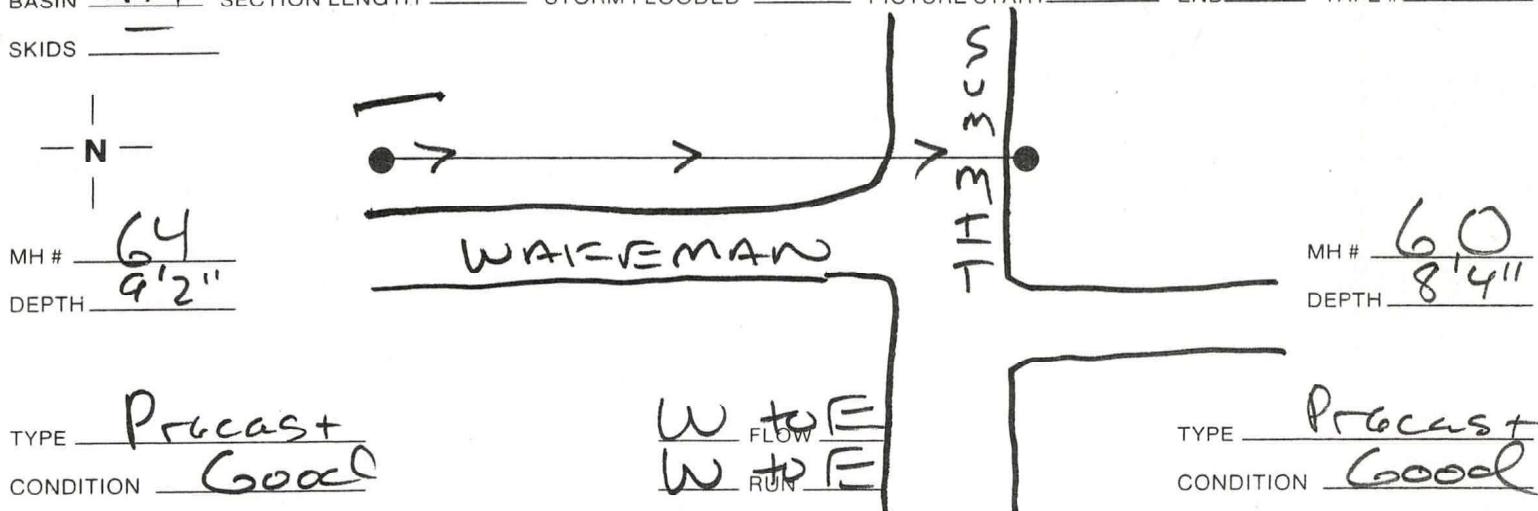
TV SEWER INSPECTION REPORT

SANITARY X STORM Linear LOCATION Walkman
SIZE 8" MATERIAL Liner BETWEEN Stoddard AND Summit
DATE 99 R.P. RECORDER — FROM MANHOLE 64 TO 60
TEMPERATURE — PRECIPITATION — GROUND CONDITION — INSPECTION FOR: Post Insitu form
BASIN 44 SECTION LENGTH — STORM FLOODED — PICTURE START — END — TAPE # —

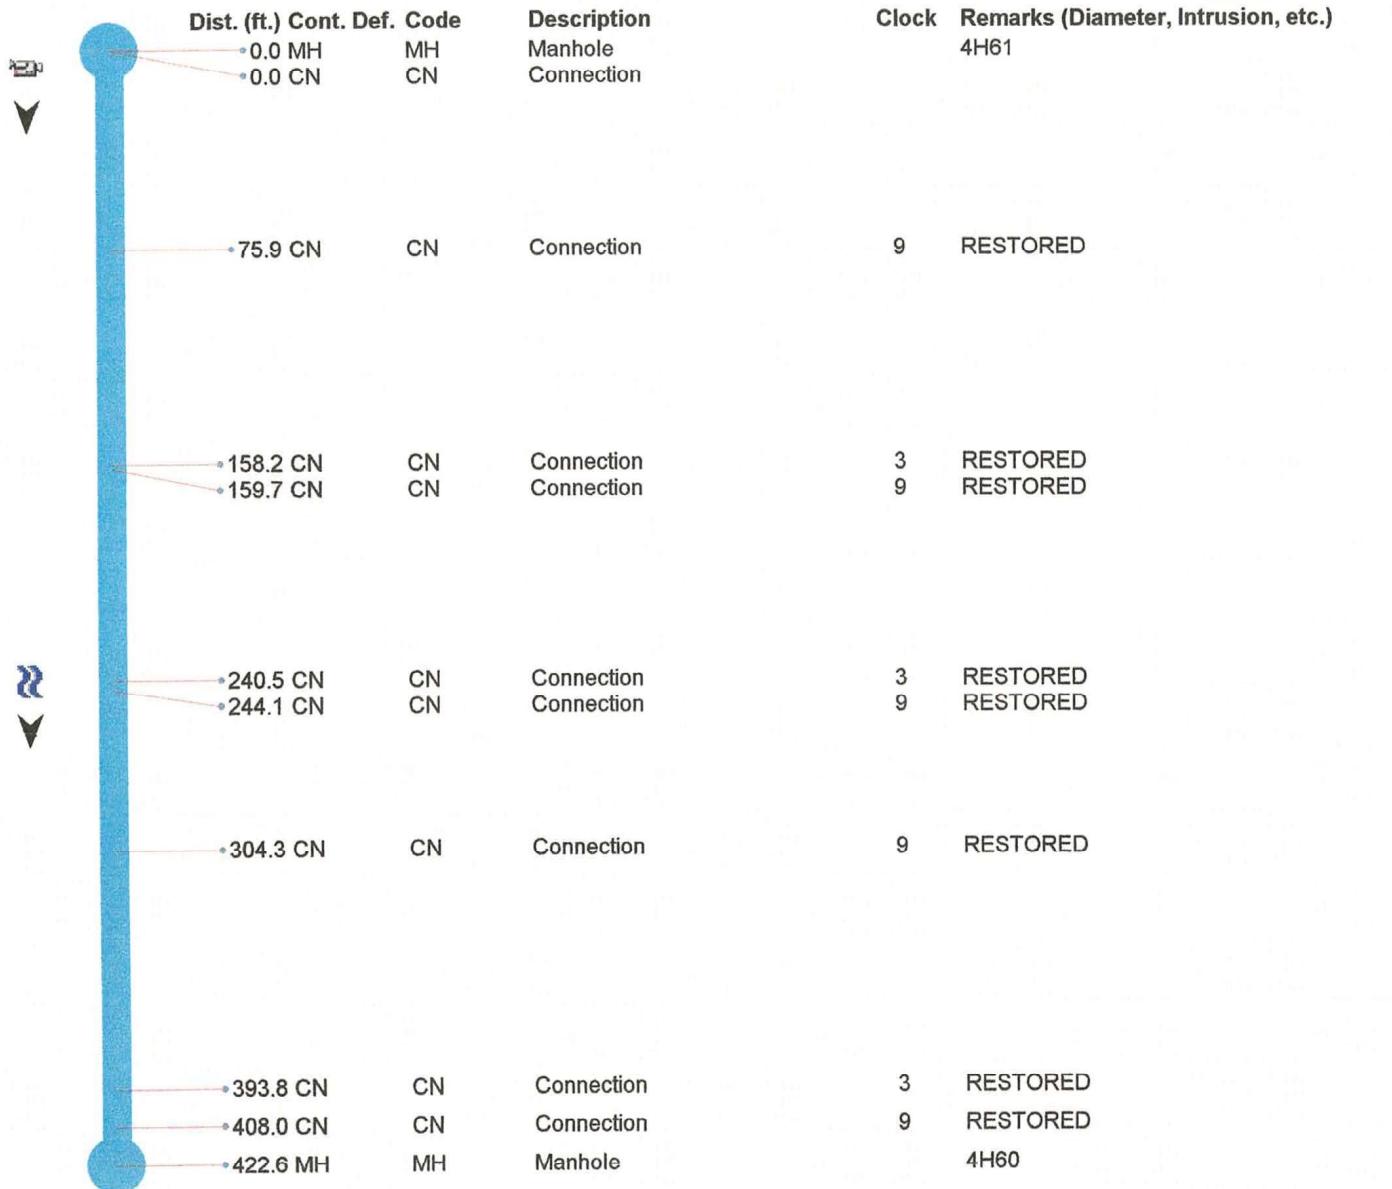
Customer Name	Job Name	Job No.	City	Surveyed By (Operator)	
City of Wheaton, IL	Wheaton 2004 Supplemental	120989	Wheaton, IL	D. COLLMAN	
Location - Road Name	Date	Size (dia) x	Field Length	Planned Length	
SUMMIT ST.	2/1/2005	8	422.6	435	
Segment #	Start Manhole No.	Depth	Finish Manhole No	Direction	Media #
023-030	4H61	15	4H60	Downstream	24
Comments - General	Material	Job Type			
	Other	Post-Main
